HD Technology Case Study:

Bearing monitoring of Paper Machine K25, Vrancart SA, Romania

Dobromir Dobrev and Nikolay Nikolaev

August 2017

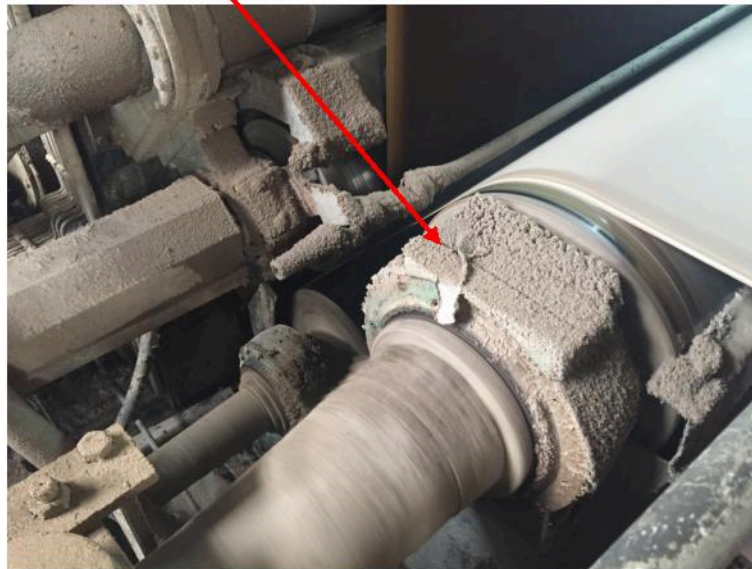
Image 1. Paper machine couch roll.

Image 1 below shows the couch roll bearing, located at the transition from the forming section (a.k.a. wet end) of the paper machine to the press section. The forming section ends with the couch roll, which passes the paper forward to the press section. The operating speed of the couch roll varies from 55 to 128 RPM.

Couch roll bearing damage

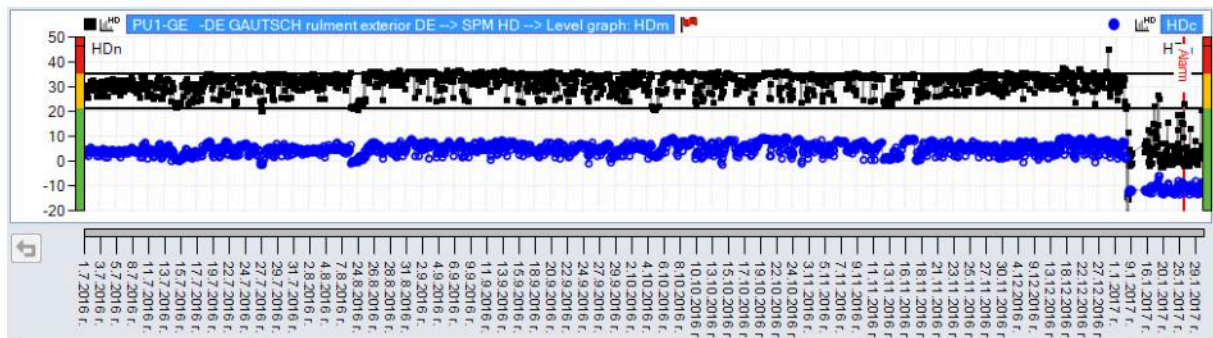
From the very beginning of the measurements on July 1st, 2016, right up until the time of bearing replacement on January 5th, 2017, HDm/HDC levels were continuously high; about 35 dB, which is on the alarm evaluation limit.

Fig 1. SPM HD trend graph HDm/HDc, from July, 2016, to February, 2017.

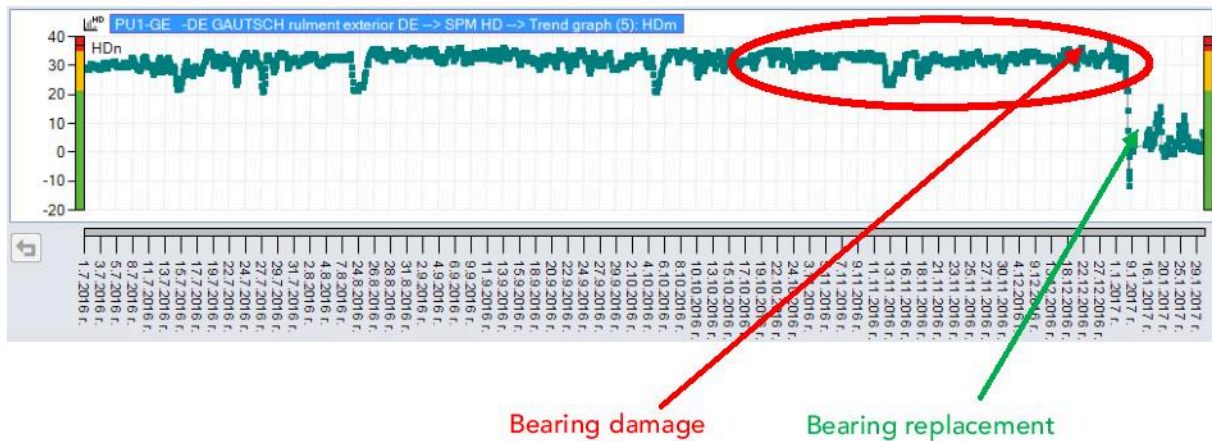
Fig 2. SPM HD averaged trend graph HDm (10 averages), from July, 2016 to February, 2017.

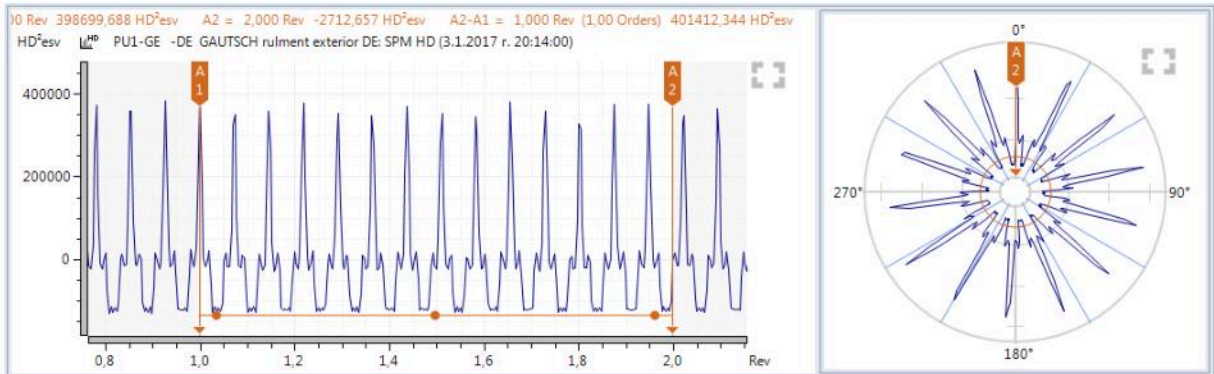
In the time signal, fourteen clear shocks per 1 revolution can be observed. In the spectrum, there are visible harmonics matching the BPFO bearing symptom for this 23096 FAG bearing.

Figure 3 shows a typical time signal for an outer race damage.

Fig 3. SPM HD Time signal and Circular plot diagram.

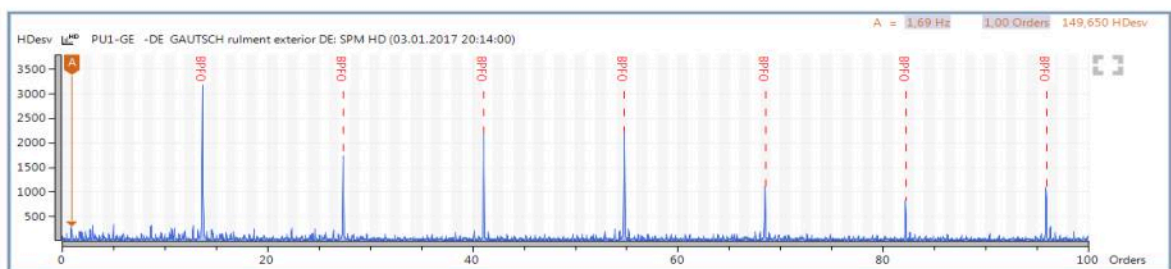
Very clear match of the BPFO symptom in the spectrum in Figure 4.

Fig 4. SPM HD Spectrum.

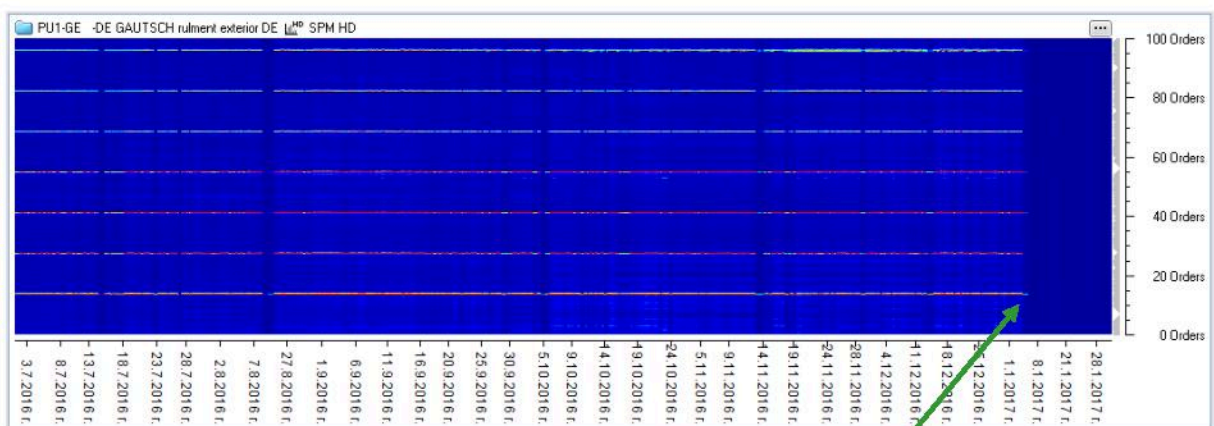
Fig 5. SPM HD Colored Spectrum Overview.

Bearing replacement

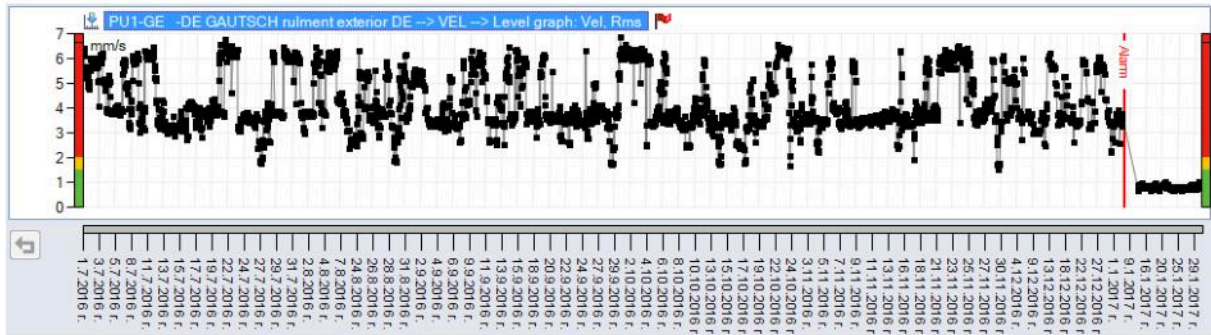
Fig 6. Velocity – VEL, trend graph, from July, 2016, to February, 2017.

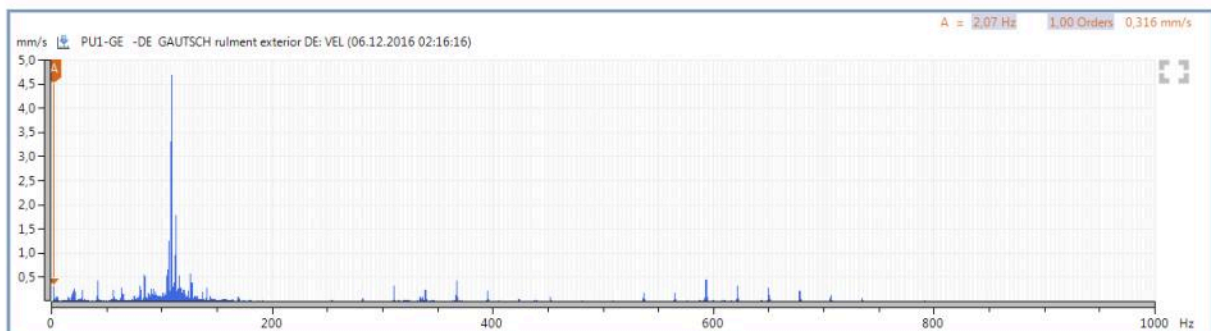
The signals just above 50X (see below) are related to the plastic seals of the vacuum chamber inside the roll. When the bearing was replaced, the seals were also replaced.

Fig 7. Velocity – VEL, Spectrum.

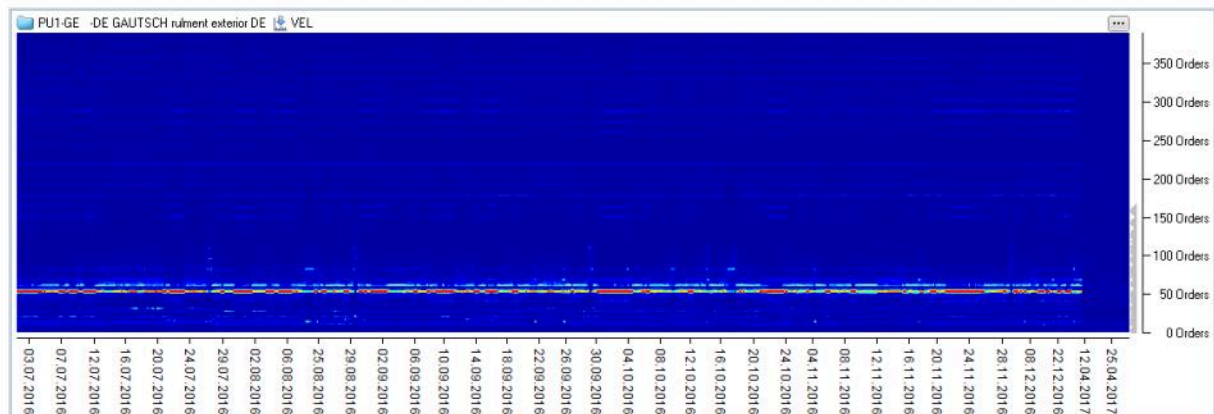
Fig 8. Velocity - VEL, Colored Spectrum Overview.

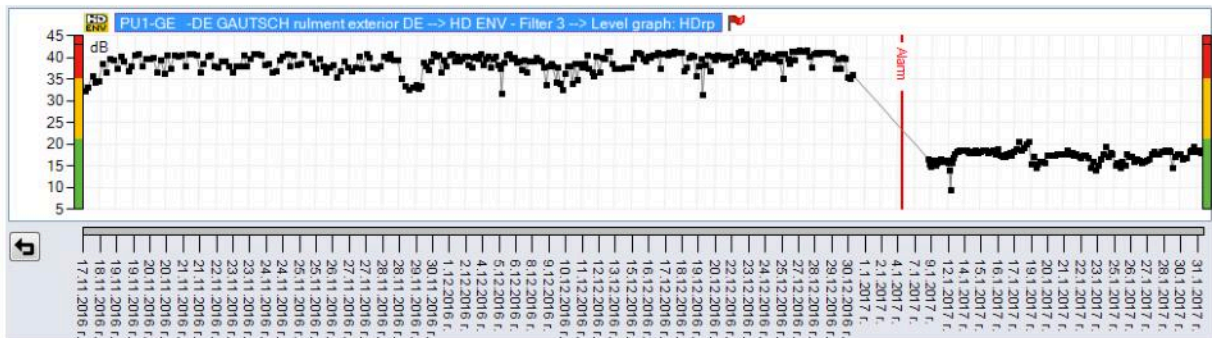
Manual alarm levels were used for HDrp settings.

Fig 9. HD ENV - Filter 3, trend graph from November, 2016, to February, 2017.

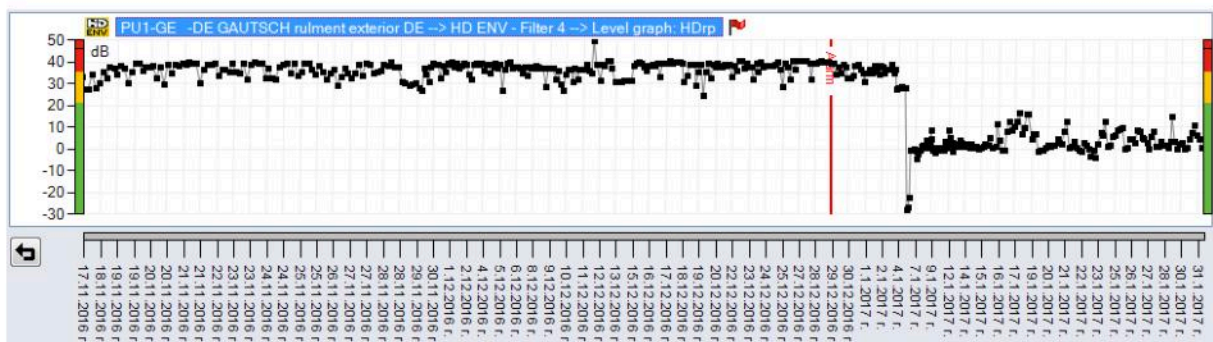
Fig 10. HD ENV - Filter 4, trend graph.

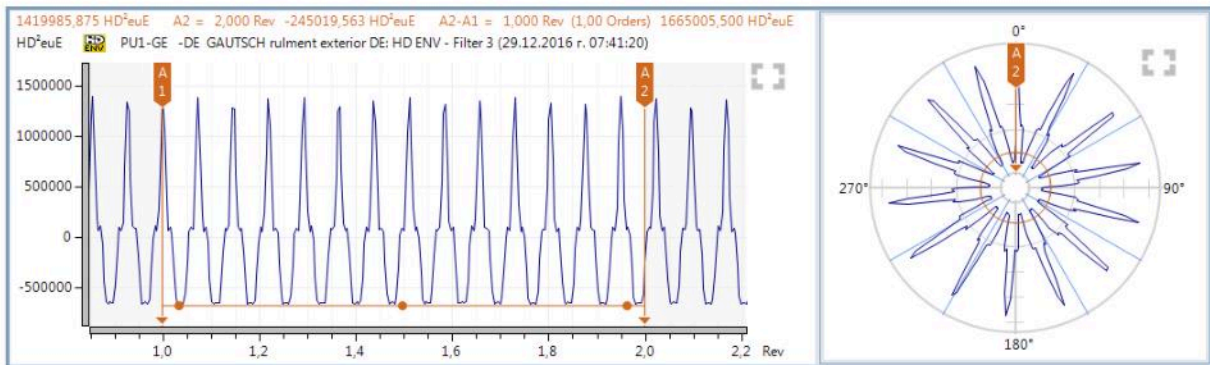
Figure 11 below shows a typical time signal for an outer race damage.

Fig 11. HD ENV - Filter 3, Time signal and Circular plot diagram.

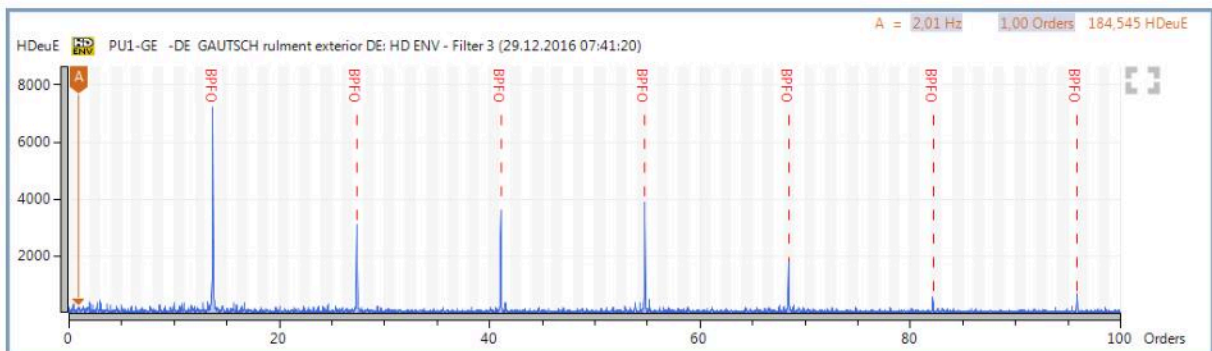
In Figure 12, a very clear BPFO match can be seen in the spectrum.

Fig 12. HD ENV - Filter 3, Spectrum.

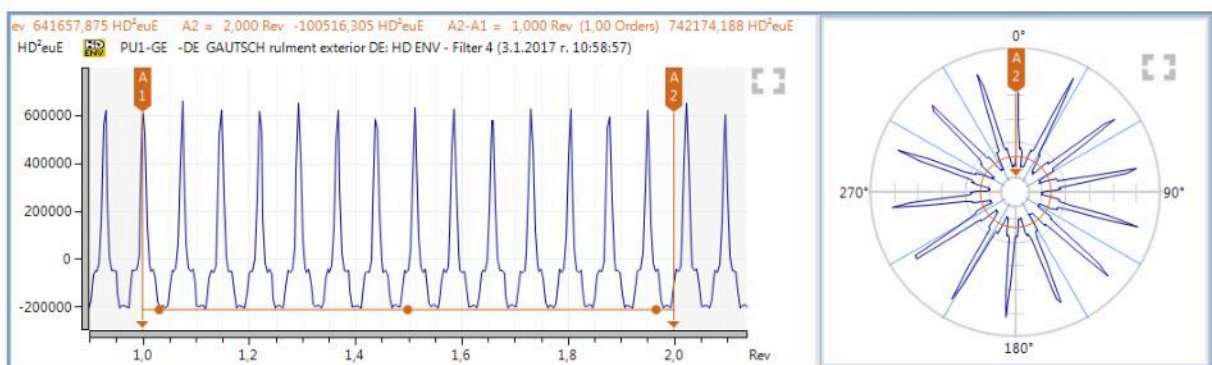
Figure 13 again shows a typical time signal of an outer race damage.

Fig 13. HD ENV - Filter 4, Time signal and Circular plot diagram.

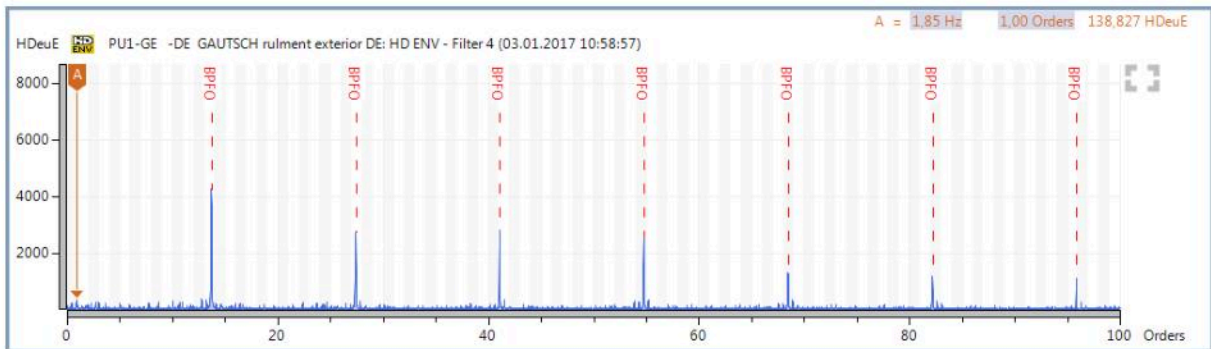
Fig 14. HD ENV - Filter 4, Spectrum.

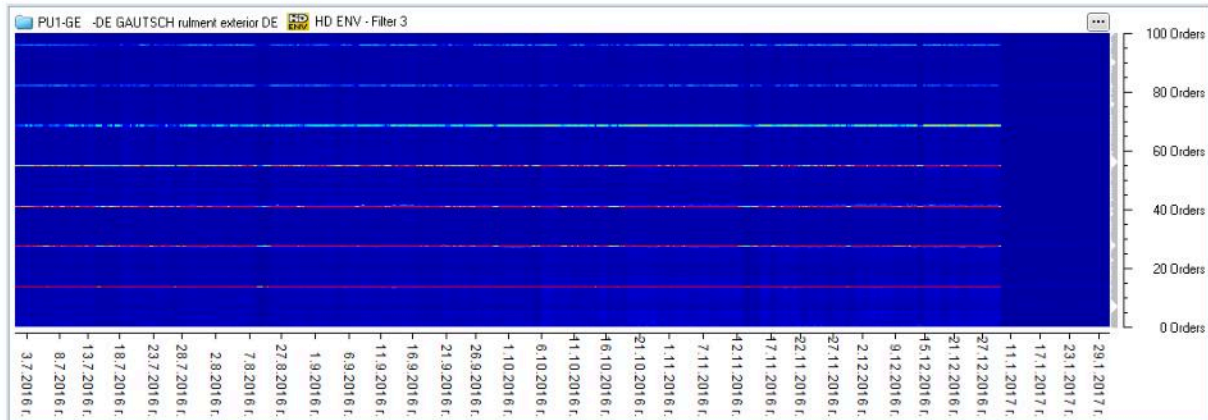
Fig 15. HD ENV - Filter 3, Colored Spectrum Overview.

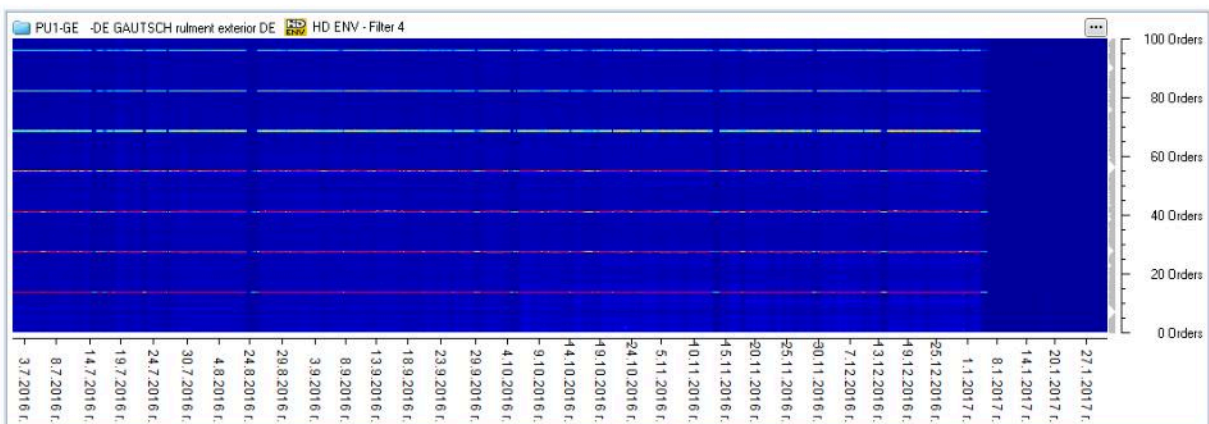
Fig 16. HD ENV - Filter 4, Colored Spectrum Overview.

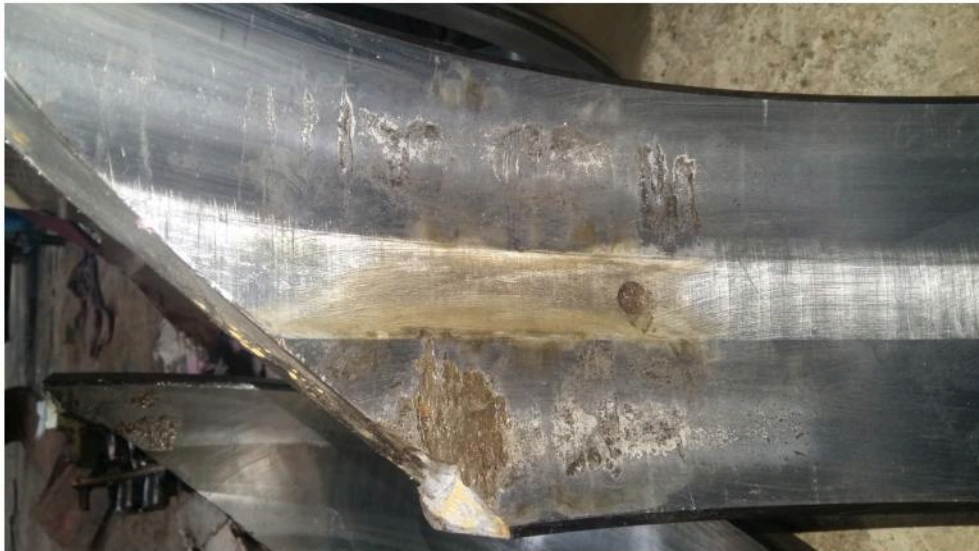
Below are photographs of the bearing after replacement. The outer ring was cut for easy dismantling. On it, the severe surface damage is visible.

Image 2. *Damage to the bearing outer race.*

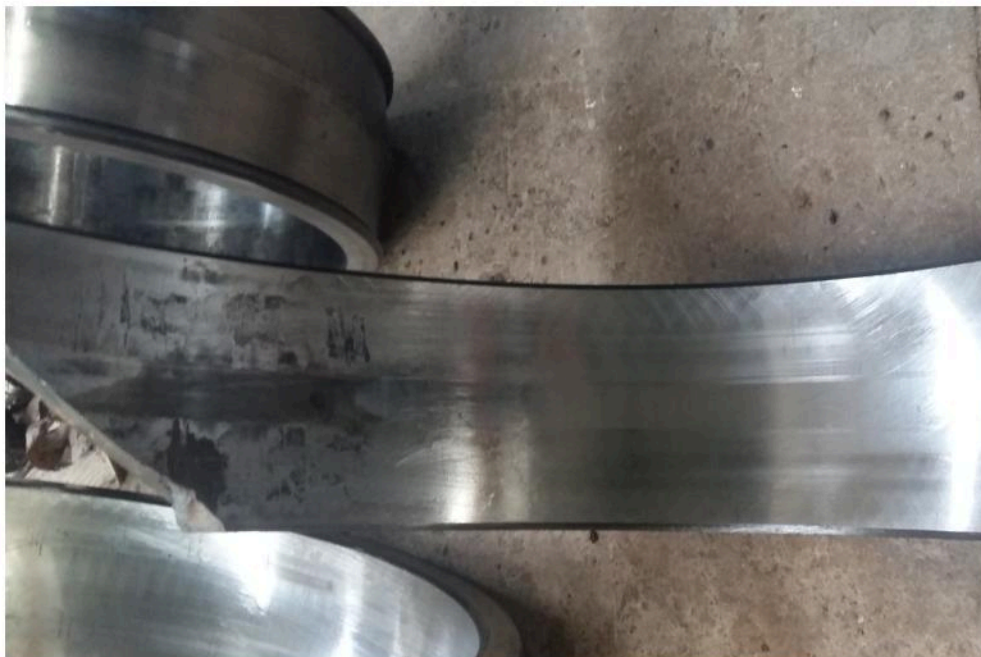
Image 3. *Outer race bearing damage.*

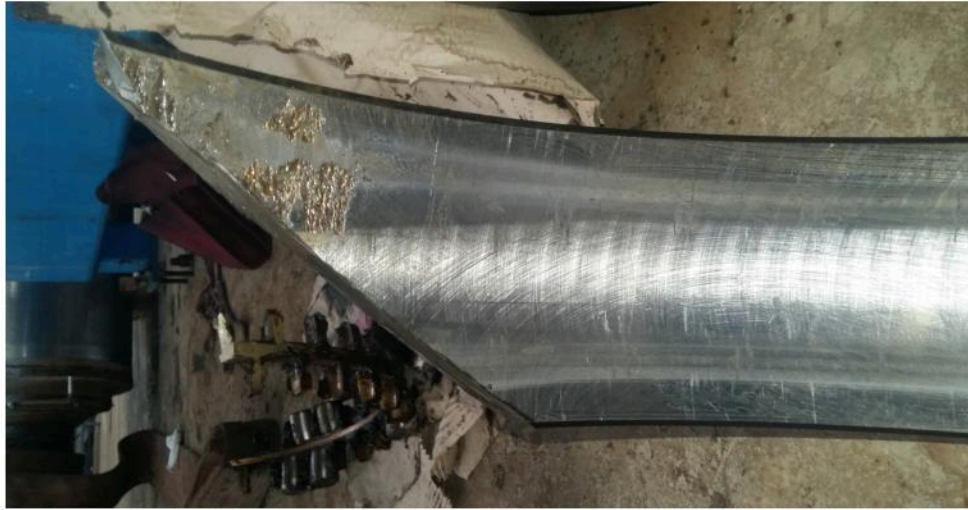
Image 4. Outer race damage.
