HD Technologies Case Study

Ball Mill bearing damage

Asarel Medet AD, Bulgaria

SPM Instrument Bulgaria EOOD

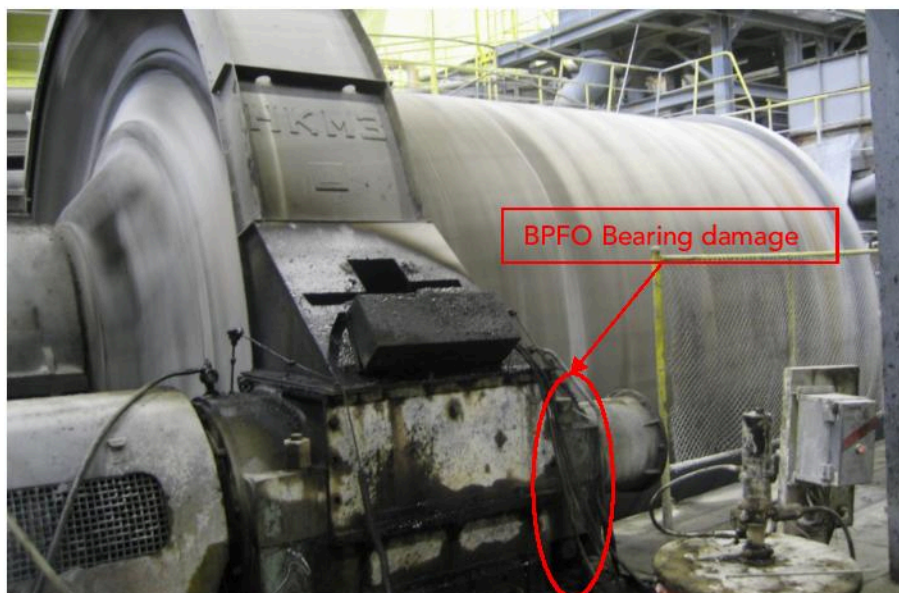
Image 1. Ball Mill No.8 at Asarel Medet AD, Bulgaria

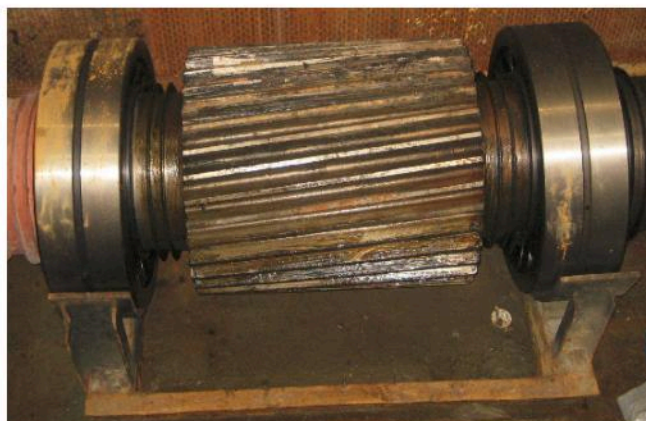
Image 2. Pinion shaft with bearings

The subject of this case study is the NDE (non-drive end) Pinion Bearing of Ball Mill N° 8 in the Mill Dpt. in the flotation plant. The bearings on the pinion are of type 22380YMB.

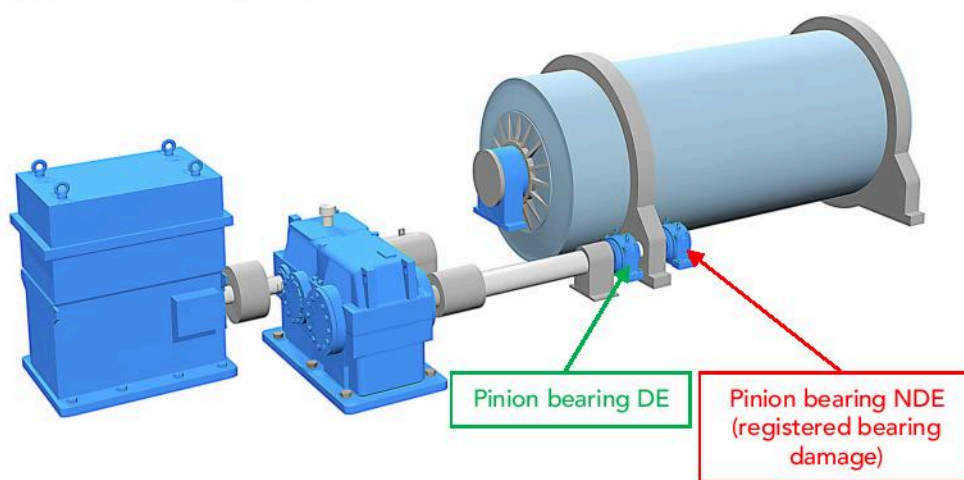
Fig 1. Typical ball mill arrangement

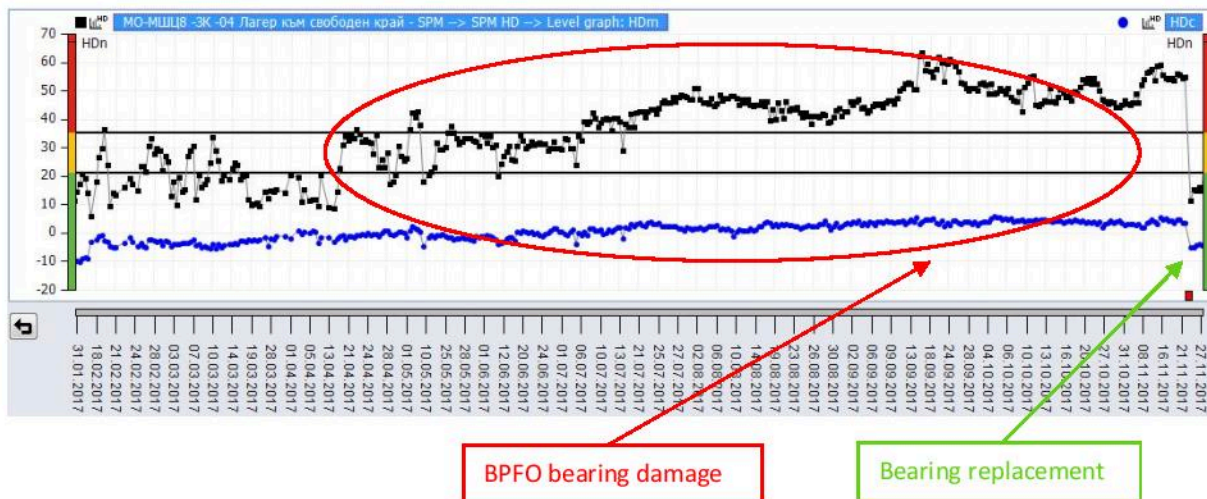
Fig 2. SPM HD trend graph HDm/HDc, from January 2017 until November 2017, measuring point Pinion bearing NDE.

At the beginning (February 2017), the SPM HD trend had varying shock pulse levels HDm/HDc (depending on the load on the mill) from 14/-2 dB (green evaluation) to 29/-3 dB (yellow evaluation). From April 23rd, 2017 the levels started to increase, and after July 2017 they exceeded red evaluation, i.e., alarm status. After September 17th, 2017 the levels reached HDm/HDc = 63/-4 dB (red evaluation). In the SPM HD Spectrum, there were clear BPFO symptom matches for the 22380YMB bearing.

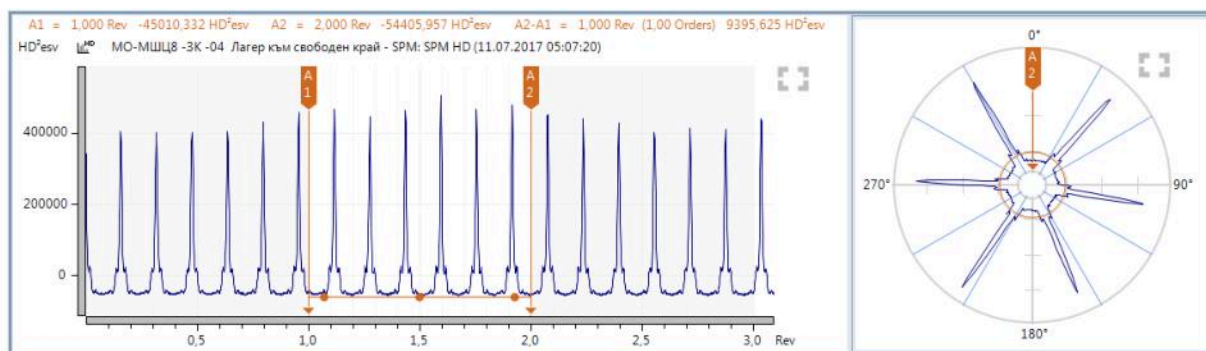
Fig 3. SPM HD Time signal - Pinion bearing NDE.

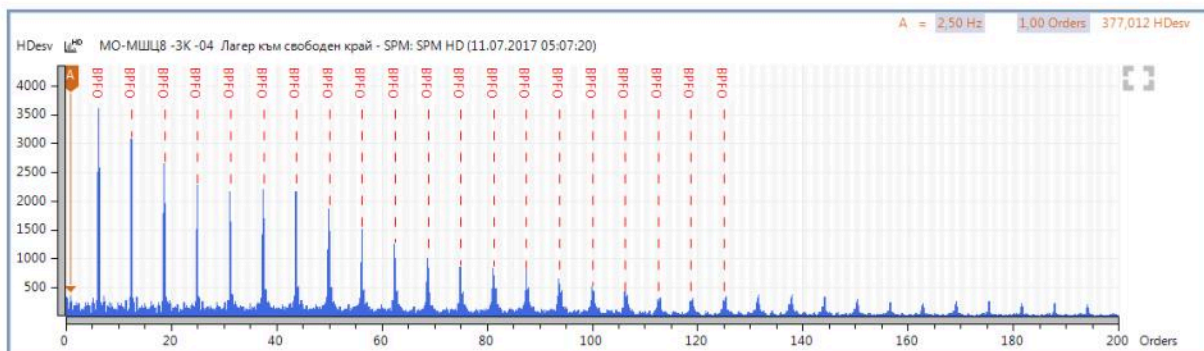
Fig 4. SPM HD Spectrum - Pinion bearing NDE - BPFO symptom match.

SPM HD Spectrum from the NDE bearing shows a clear match of the BPFO (Ball Pass Frequency Outer Race) symptom. According to the customer, following the indications for bearing damage from Condmaster Ruby they replaced the pinion shaft, where they found visible signs of outer race damage on the NDE bearing.

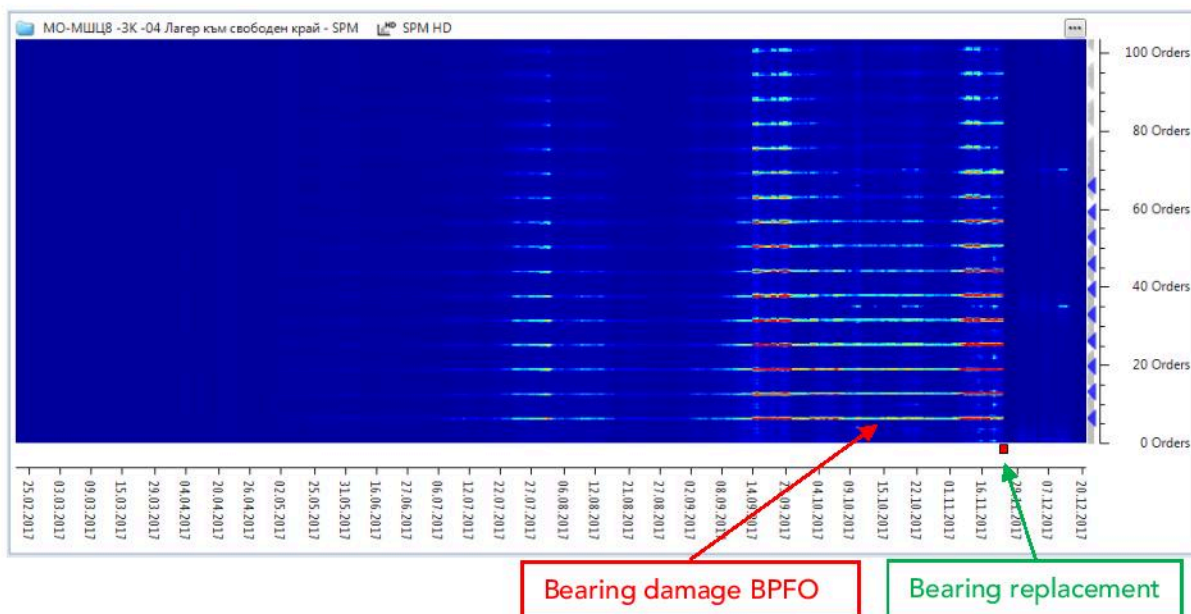
Fig 5. SPM HD Colored Spectrum Overview.

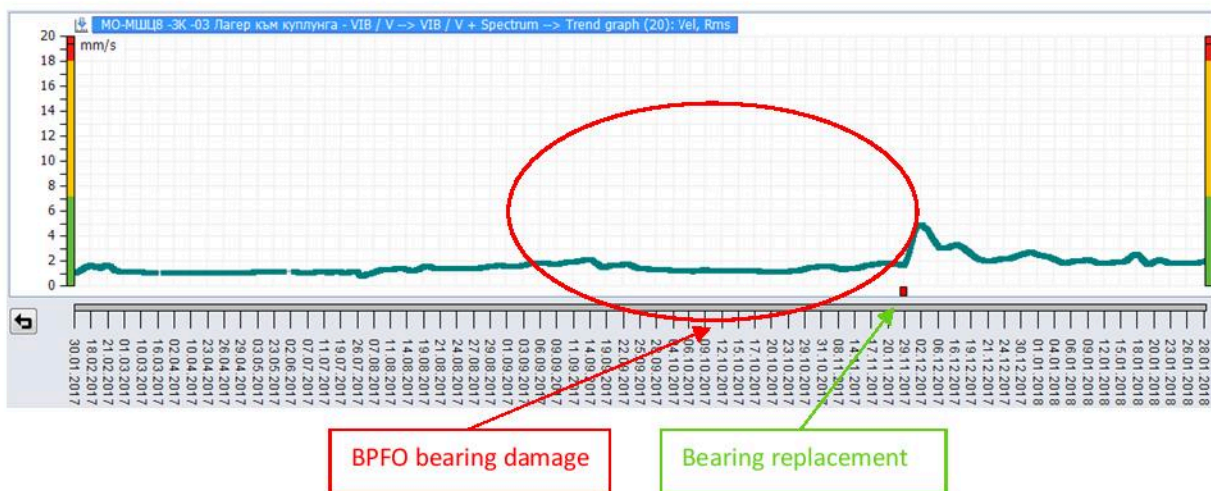
Fig 6. Velocity trend graph, from January 2017 until January 2018, measuring point Pinion bearing DE.

The vibration readings do not show any sign of damage.

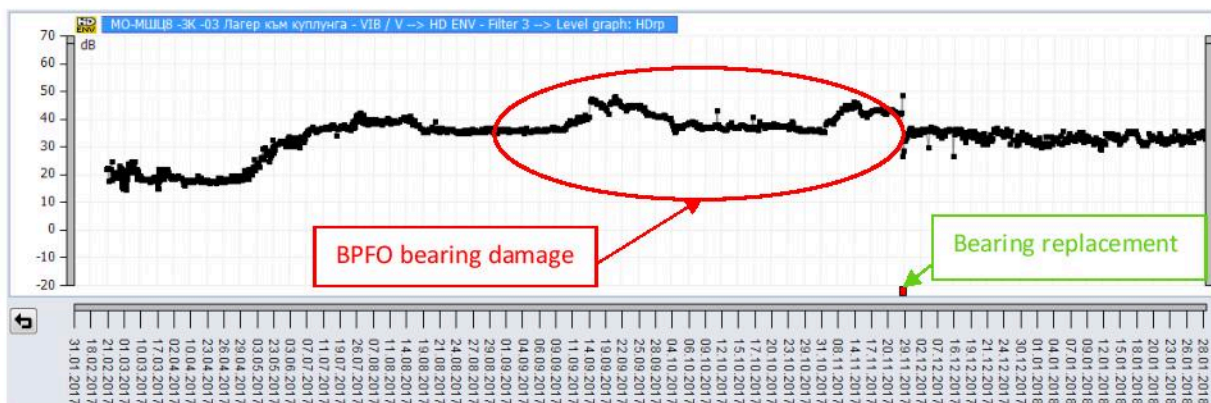
Fig 7. HD ENV, Filter 3 trend graph, from January 2017 - January 2018, measuring point Pinion bearing DE.

The HD ENV Filter 3 trend on the DE bearing follows a pattern similar to the SPM HD trend on the NDE bearing, and also has a spectrum showing BPFO match.

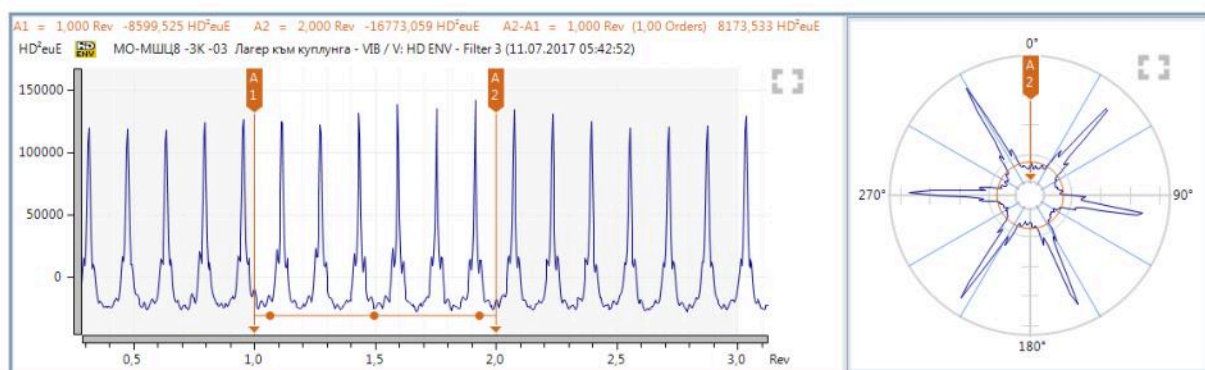
Fig 9. HD ENV, Filter 3, Time signal - Pinion bearing DE.

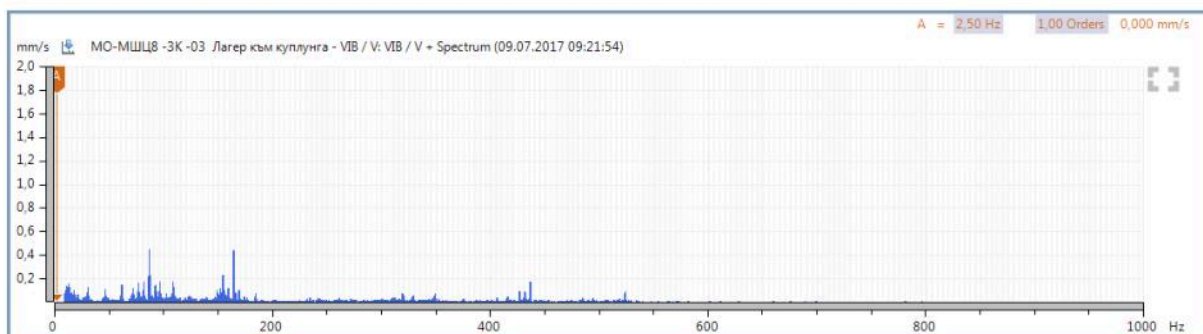
Fig 10. Velocity VEL spectrum - Pinion bearing DE.

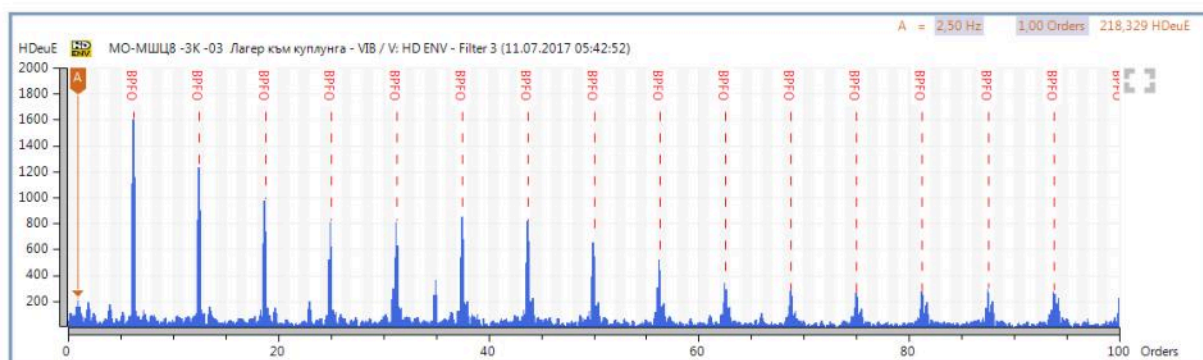
Fig 11. HD ENV Spectrum, Pinion bearing DE - BPFO symptom match from NDE.

Due to the close distance between the two bearings, the vibration sensor mounted on the DE bearing picks up the signal from the NDE bearing.

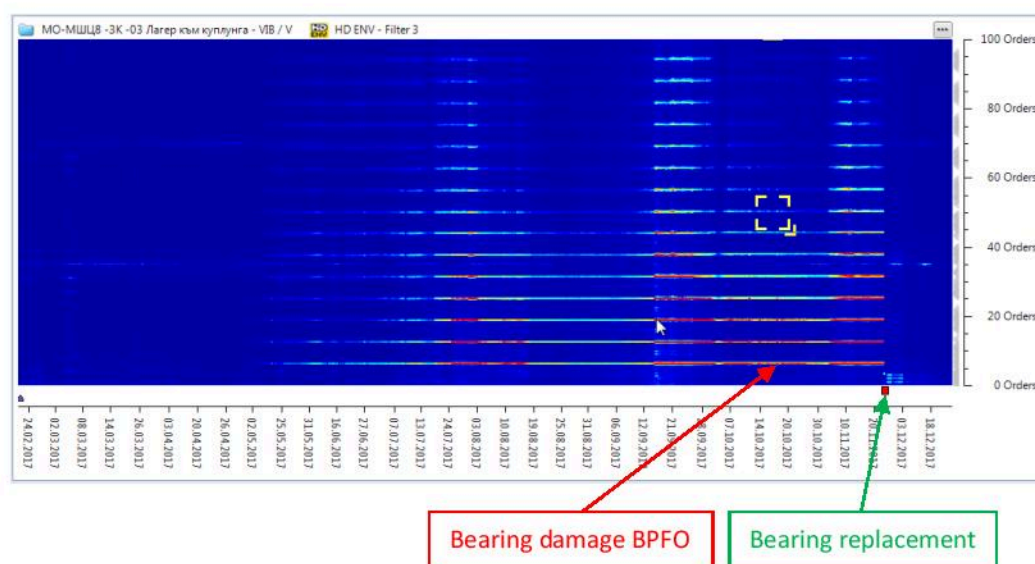
Fig 12. HD ENV, Filter 3, Colored Spectrum Overview - Pinion bearing DE.

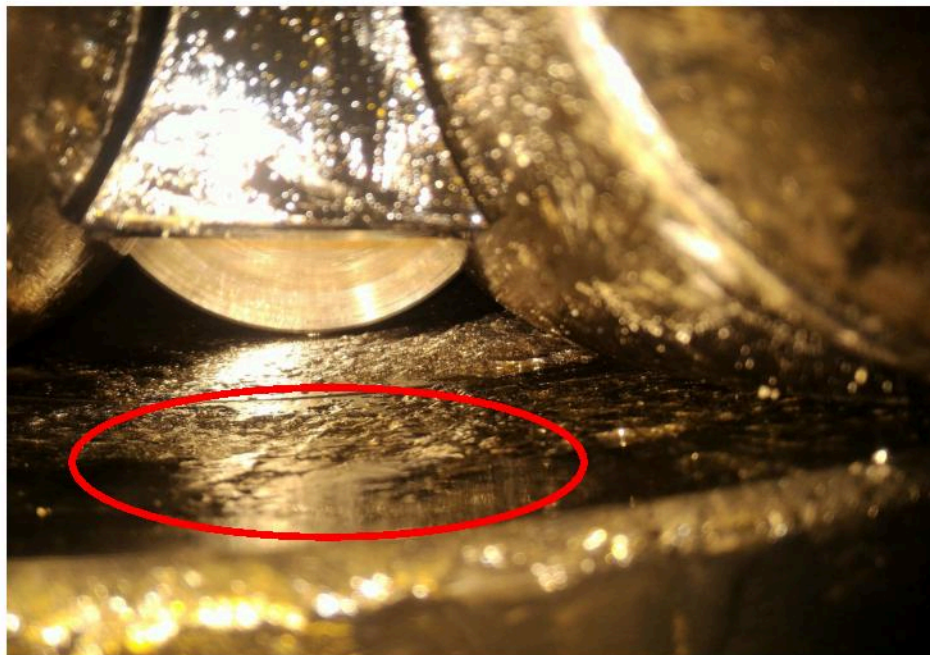
The picture below show the visible signs of bearing damage on the outer race surface.

Image 3. Outer race damage.

On 26.11.2017, during a regular maintenance stoppage, the bearing was replaced.
